A low-tech depot for Roman archaeological finds

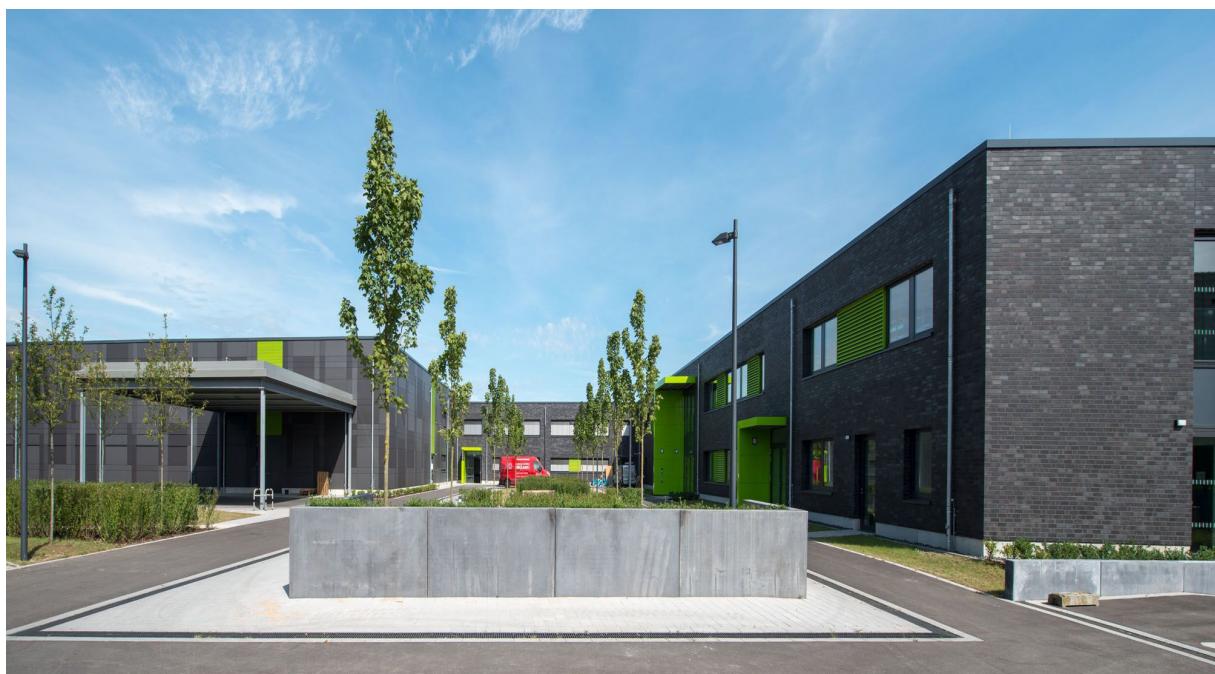
01 The new office building at LVR Archaeological Park Xanten. On the right is the administrative wing, on the left is the depot for the archaeological finds. (Photo: Axel Thünker DGPh)

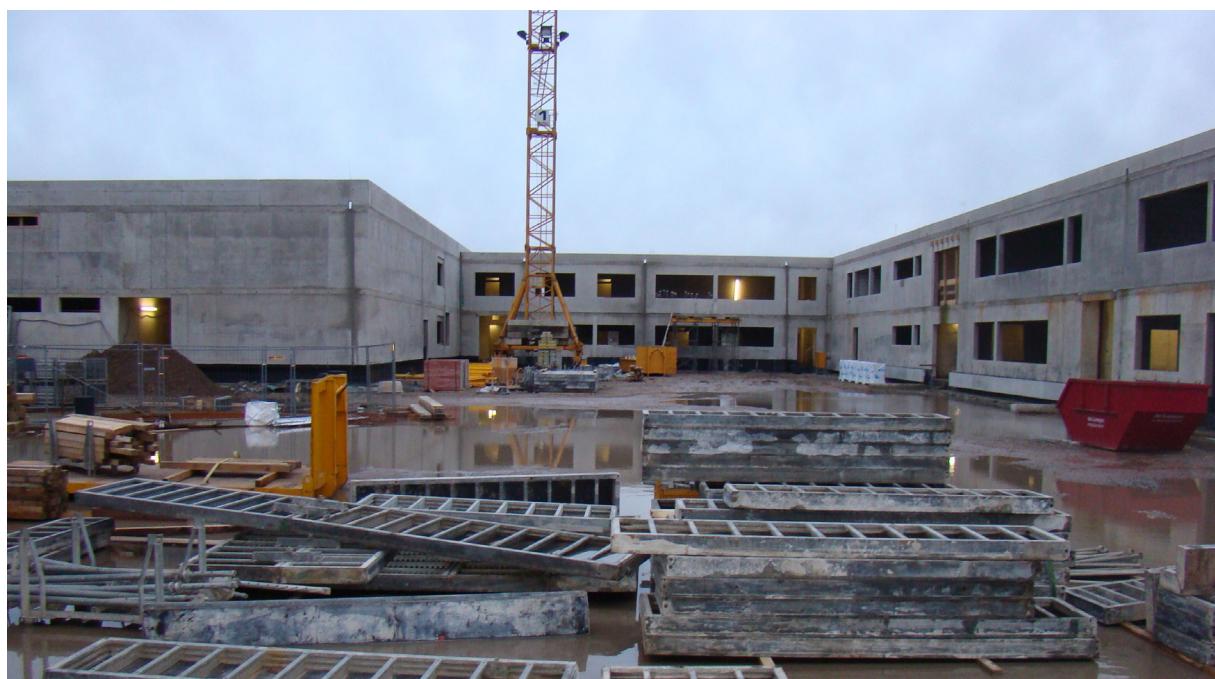
02 The new office building during construction. The find depot (left) is clearly recognisable due to its lack of windows

reinforced water impervious concrete on 20 cm thick compacted gravel bed (Fig. 2) topped by a PE foil moisture barrier. The floor surface is a 6 cm screed compound and the floor is not otherwise insulated. The external walls are 24 cm reinforced concrete with 10 cm of mineral wool insulation and a curtain-type, back-ventilated panel cladding. The ceiling slab is 22 cm reinforced concrete with a rigid EPS thermal insulation cut to fall (min. thickness 12.5 cm) topped by an extensive green roof. Both the ventilated wall cladding and the green roof are designed to prevent the thermal insulation being exposed to particularly high or particularly low temperatures.

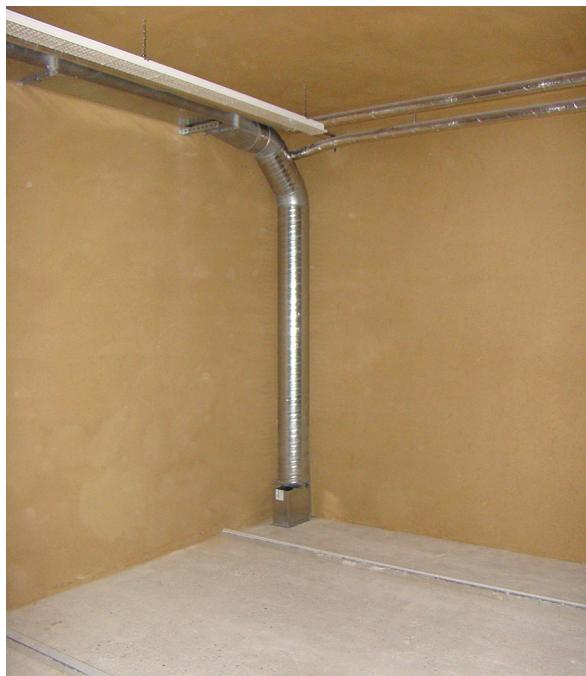
03 Section of the depot with clay plaster walls, ventilation ducts, wall heating supply and return pipes in the corner and the rails of the sliding racks on the floor

Inside, the walls and ceilings were given a two-layer coating of clay plaster (Fig. 3). The plaster thickness on the ceiling and walls is 25 mm. On the inner face of the external wall, warm-water wall heating coils have been embedded in the plaster, which is slightly thicker 30 mm (Fig. 4). Given the floor space of approx. 1,420 m², a total of 2,870 m² of wall surfaces were coated with clay plaster. Such a large surface area should be able to quickly absorb moisture from the air in the room and slowly release it again, thus stabilising the room climate.

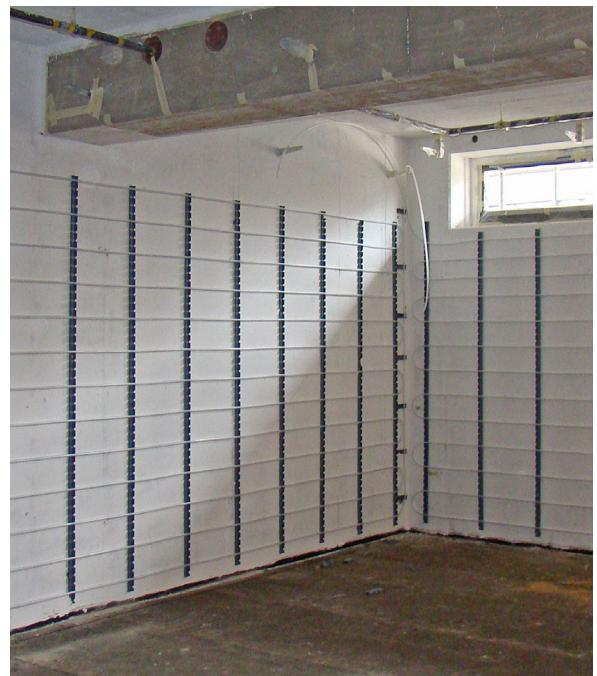
04 Pipes of the wall heating registers prior to application of the clay plaster

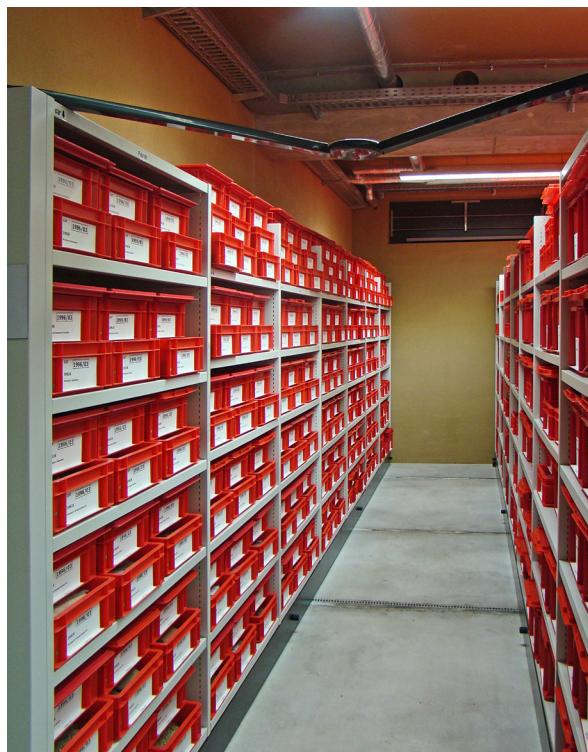
05 Sliding shelf system with red boxes containing finds showing clay plaster walls and smoke extraction vents

The interior is fitted primarily with electrically driven sliding tracked shelves (Fig. 5) which are programmed so that they automatically return to the home position at the end of the day, where the shelves are evenly spaced. This ensures that all the boxes with finds are ventilated and no "dead pockets" result.

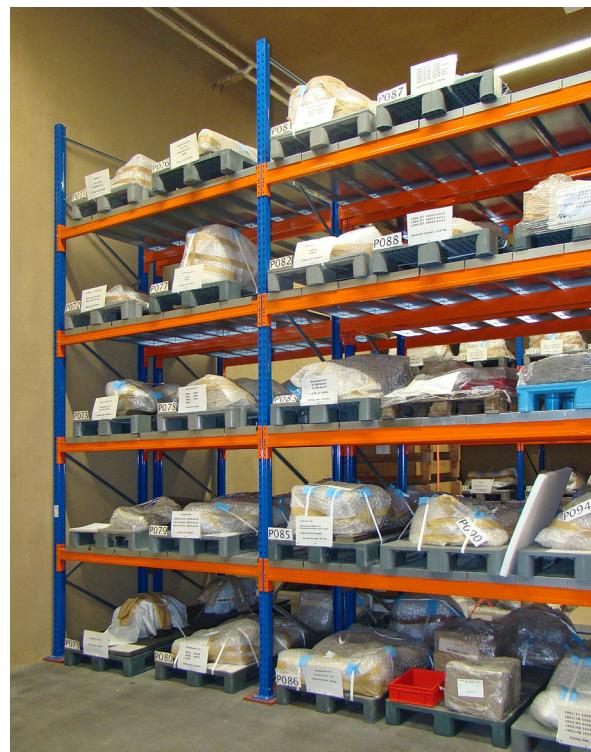
06 The two-storey depot for large finds. On the ceiling the supply line to the wall surface heating.

In the display and pick-up depots, regular shelving is provided, and in the stone depot, tall shelves capable of holding pallets were installed (Fig. 6).

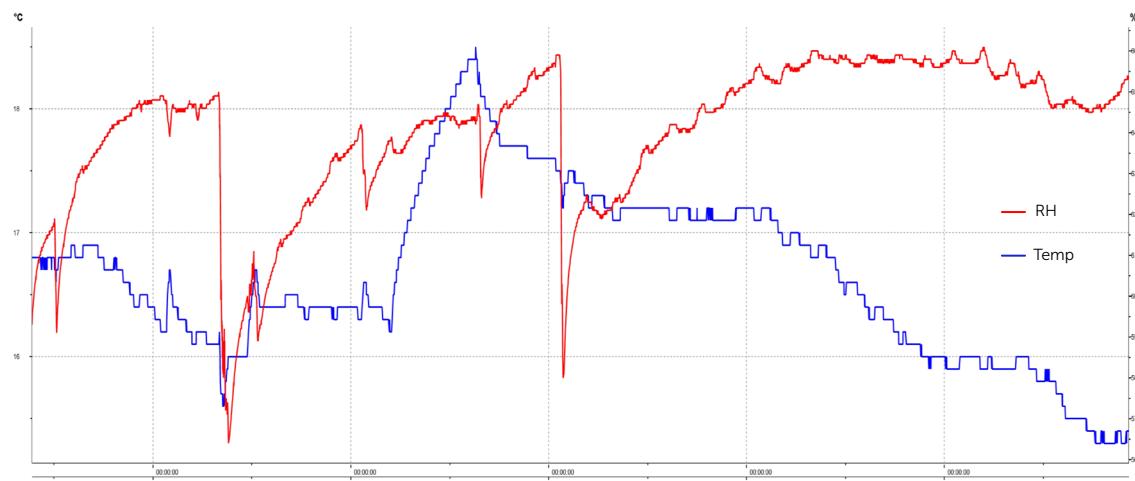
09 Temperature and humidity curves from 30 Nov 2016 to 08 Jan 2017 in Depot D113 (Datalogging: Peter Becker).

A similar pattern can also be observed in winter, although there are some differences. On the one hand, the wall surface heating starts to operate below an outside temperature of approx. 18°C, providing additional warmth inside the depot to act against falling temperatures. The wall heating is supplied with a flow temperature of 25°C and can thus usually maintain

a room temperature of approx. 18°C, though after a series of very cold days the temperature can drop to 14°C. The lower design limit was not to fall below a minimum temperature of 11°C, a value derived from statutory requirements (EnEV). The current minimum temperature of 14°C represents a good solution, and in fact only prevails on a few days.

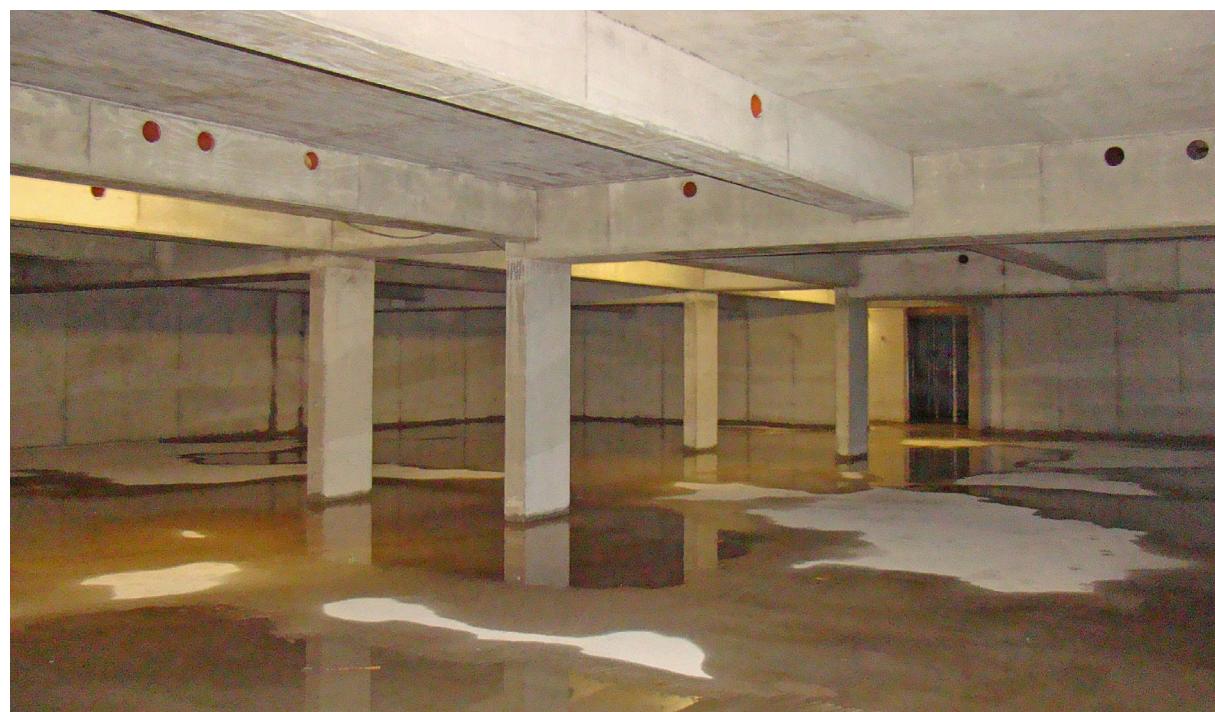
10 Depot D113 during the construction phase showing rainwater pooling on the ground

Initially, the moisture contained within the building itself during construction was not sufficiently taken into account. The floor slab and side walls up to a height of one metre are made of water impervious concrete, with normal reinforced concrete above. As the rooms of the depot have only small openings for smoke extraction vents, the air exchange rate during the curing and drying process was very low (Fig. 10). The application of clay plaster also introduces further moisture into the building. However, the ventilation system that was installed later in the construction process was dimensioned only for the minimum air exchange and could not help accelerate the drying process. Consequently, humidity levels in the depots was very high at first, so that in September 2016 only the admin staff and researchers could move into their new offices. The finds were left in the old depot so that the new depot could dry out over a winter period by selectively opening the smoke extraction flaps on cold, dry days to manually ventilate the interior. Although this produced a significant short-term drop in room air humidity, the building structure released new moisture after a short time. For this reason, additional dehumidification units were installed in the storage rooms to promote dehumidification when the vents could not be opened.
